Northern Climate ExChange

# Final Report: Dempster Highway Permafrost Assessment

March 2014

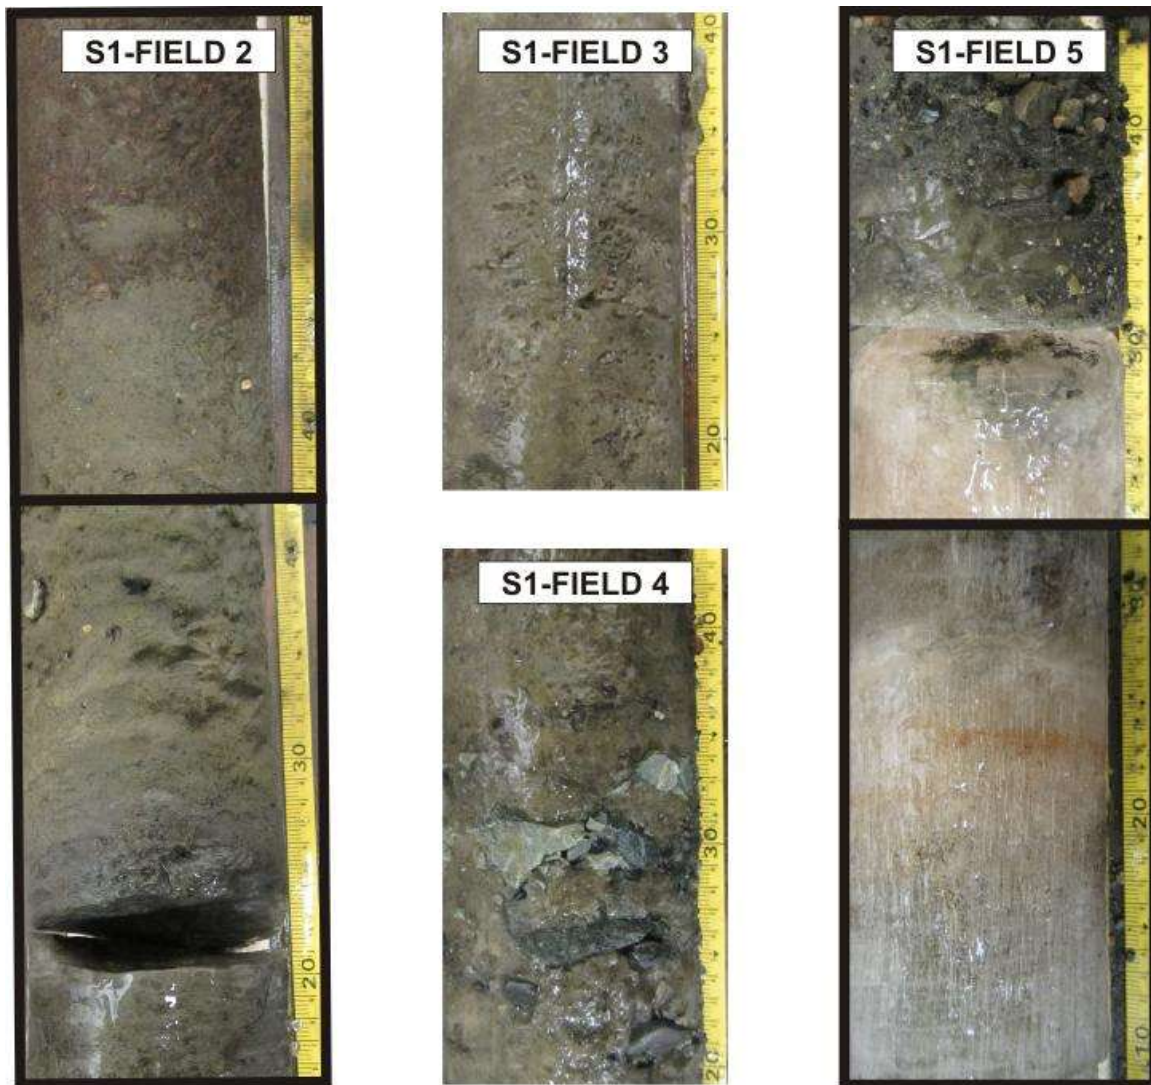
**Permafrost features for Site 1 under the Field.**

S1-Field: located in the field (N64.90321 W138.27828). This site was drilled down to 28ft (8.53 m). The soil was frozen down to 3.5 m, cores were collected down to this depth (5 samples). Below, the soil reverted to gravelly, apparently unfrozen condition; and cuttings were collected during (5 sample bags). The borehole was sufficiently stable to allow pvc tubing to be installed.

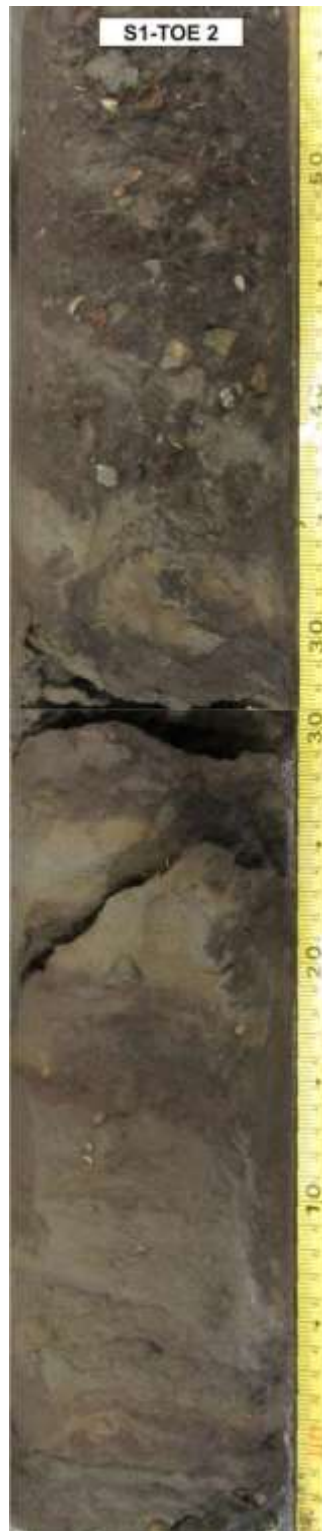
S1-TOE

Core No	Soil testing	Soil	Ground Ice
0 m	1	b	Dark Silt (cuttings) Unfrozen or thawed (U/T)	📷 = see facies photo
1 m	2	a, b, c, d, f	Dark silt with gravel, and organic levels	No visible excess ice
	3		Gravel (cuttings) (U/T)	
2 m	4	a, b, d	Gravelly sediment: Gravel in dark silt (cuttings) (U/T)	
3 m	5		Gravelly sediment: Gravel in dark silt (cuttings) (U/T)	Wedge Ice followed by suspended in ice
4 m	6		Gravelly sediment: Gravel in dark silt (U/T) (cuttings)	
5 m				
6 m	7		Gravelly sediment: Gravel in dark silt (U/T) Maybe less coarse (cuttings)	
7 m	8	a, b	Gravelly sediment: Gravel in dark silt (U/T) (cuttings)	
8 m	9		Gravelly sediment: Gravel in dark silt (cuttings) (U/T)	
		8.53 m		
9 m				
10 m

**Permafrost features for Site 1 under the toe of the Embankment.**

S1-Toe: located at the toe of the embankment (N64.90316 W138.27801). This site was drilled down to 28ft (8.53 m). The soil appeared to be coarse, gravelly, and unfrozen. Cuttings were collected during the drilling process (9 sample bags), but no frozen cores were retrieved. The borehole was instable and caving; no pvc tubing was installed.

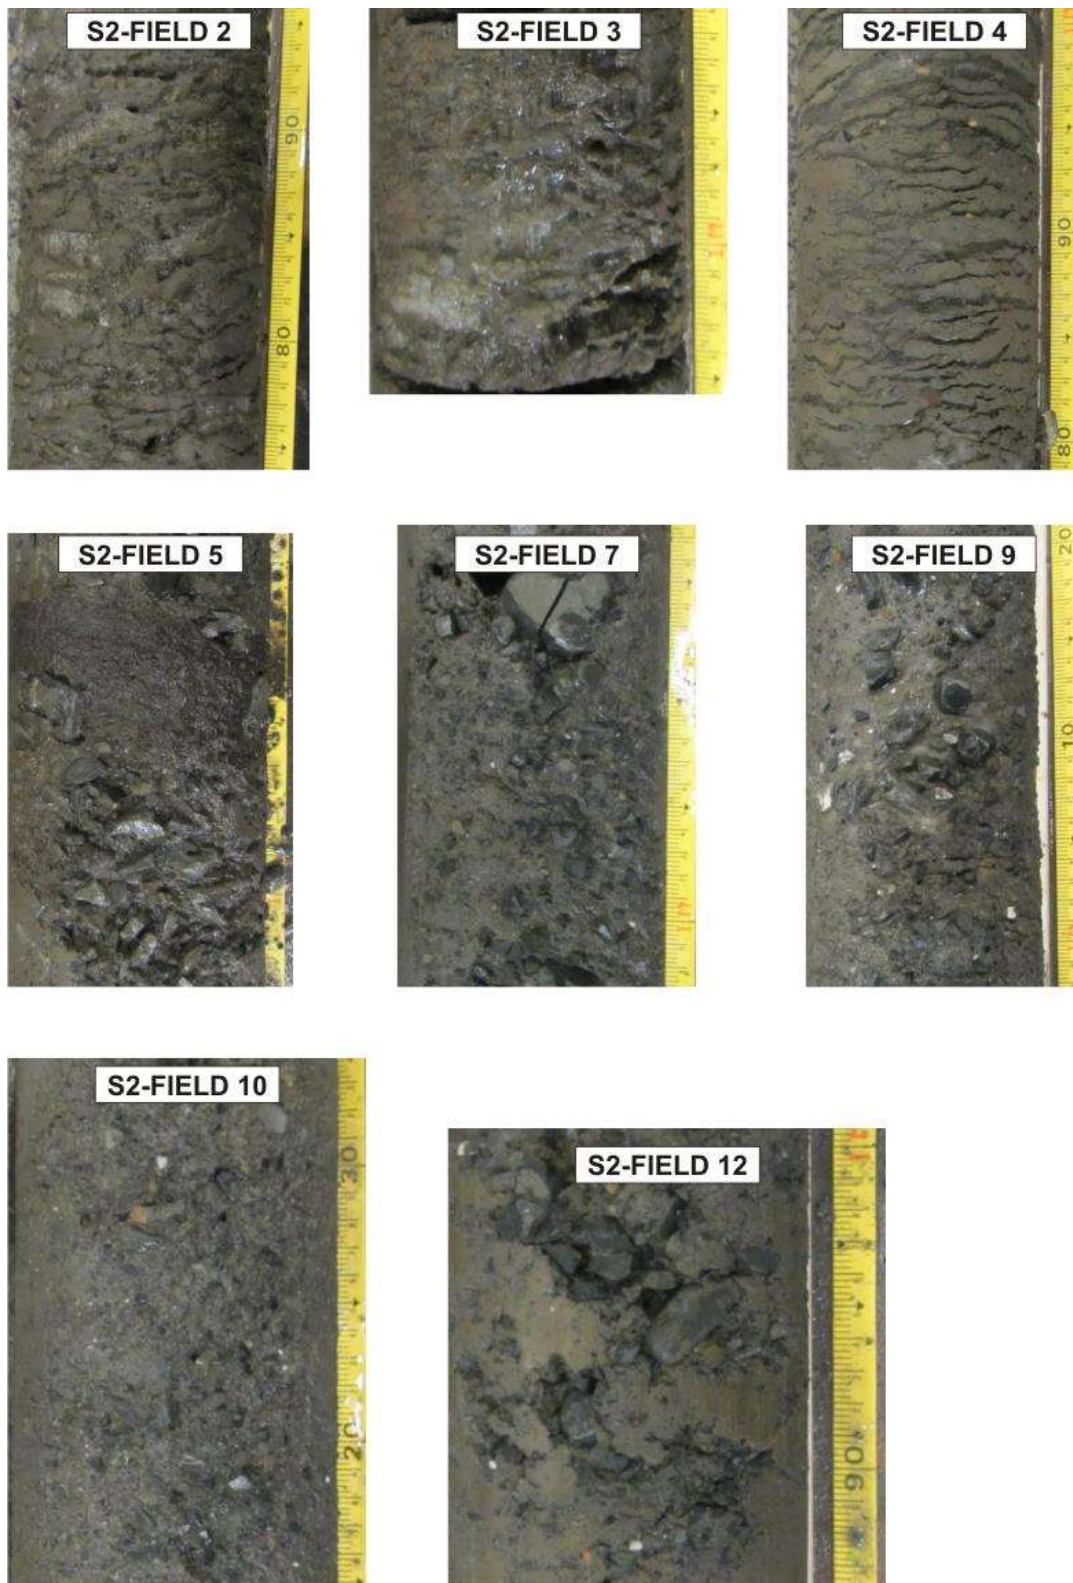
Core No	Soil testing	Soil	Ground Ice
0 m	1	b	Brown, organic silt Unfrozen (cuttings)	☉ = see facies photo
1 m	2	☉ a, b, c, d	Brown diamicton- Peat layer @ top	Ice-rich: suspended
	3	☉	Brown diamicton	Ice-rich: suspended
2 m	4	☉ a, b, c, d, f	Brown diamicton - organics (putrid odor - muck)	Ice-rich: layered to suspended
3 m	5	☉ a, b, d	Diamicton: gravel in brown silt - organics (putrid odor - muck)	Ice associated with organics
	6		Diamicton	Ice-poor
4 m	7	☉	Diamicton	Visible cement ice
	8		Diamicton	Ice-poor
5 m	9	☉ a, b, d	Diamicton	Ice-poor
6 m	10	☉	Diamicton	Ice-poor - thin ice layer @ base
	11		Diamicton	Ice-poor
7 m	12	☉	Diamicton	
	13	a, b, d	Diamicton - Angular Schist debris in fine matrix (cuttings)	
8 m	14		Diamicton - Fine material and gravel(cuttings)	
	8.53 m			
9 m				
10 m

**Permafrost features for Site 2 under the Field.**

S2-Field: located in the field (N66.70092 W136.35819). This site was drilled down to 28ft (8.53 m). The soil appeared to be fine sediment with level of gravel. The cores were mostly frozen, yet discrepancies exist between length and depth of the some of the cores. Fourteen (14) samples were collected. The borehole was stable, and pvc tubing was installed.

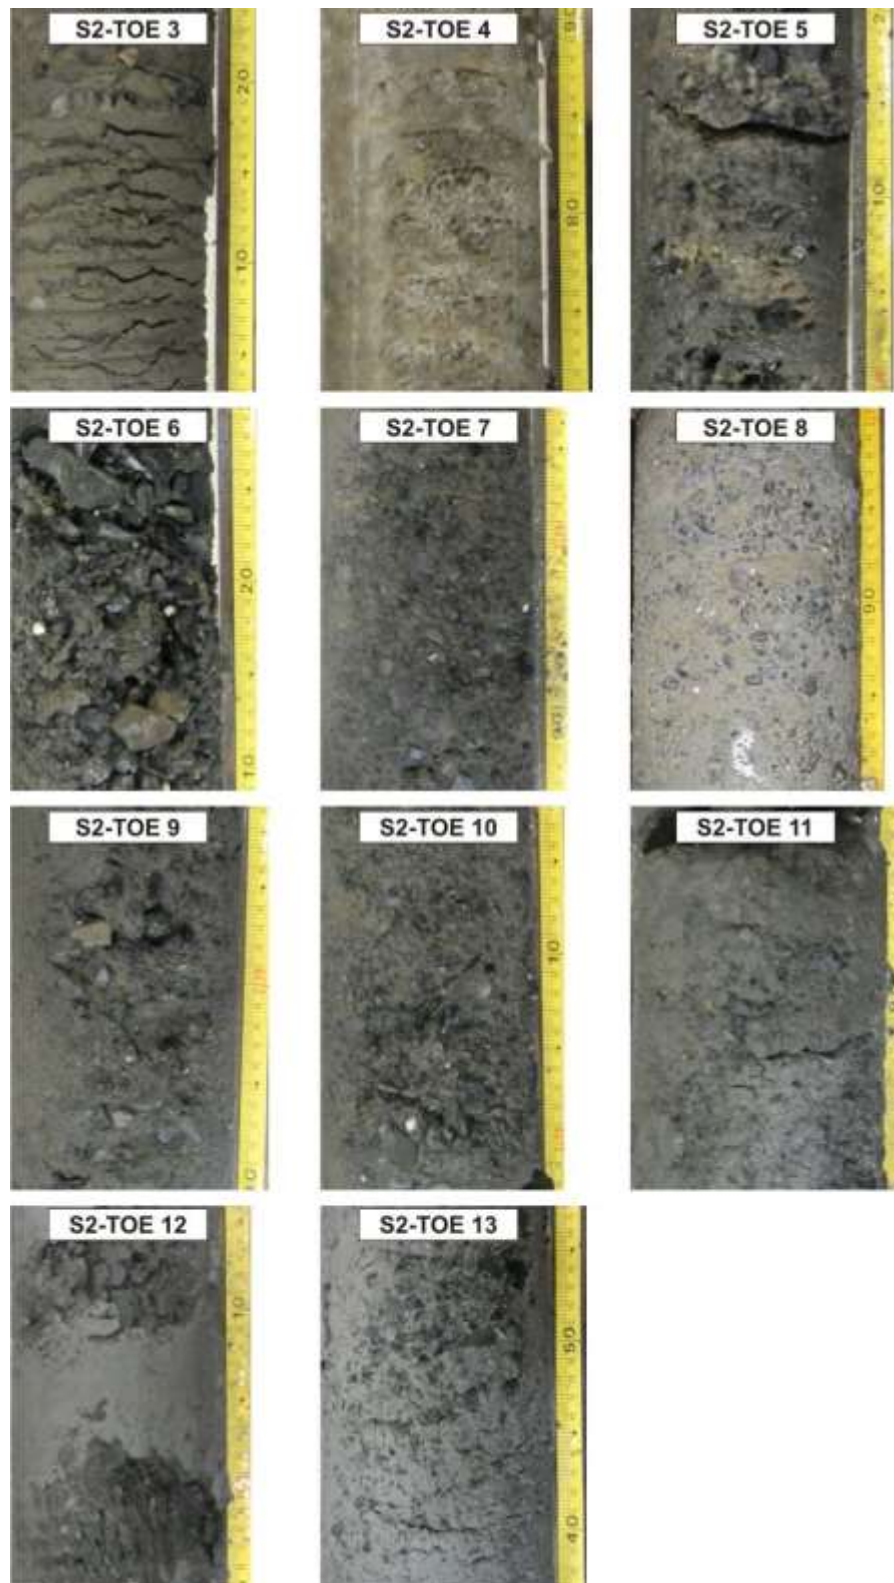
**Permafrost features for Site 2 under the toe of the Embankment.**

S2-Toe: located at the toe of the embankment (N66.70089 W136.35854). This site was drilled down to 29ft (8.84 m). The soil appeared to be fine sediment with level of gravel. The cores were mostly frozen, but may have been altered by the drilling process as, often, length of the cores were inconsistent with the depth provided by the driller. Thirteen (13) samples were collected. The borehole was stable, and pvc tubing was installed.

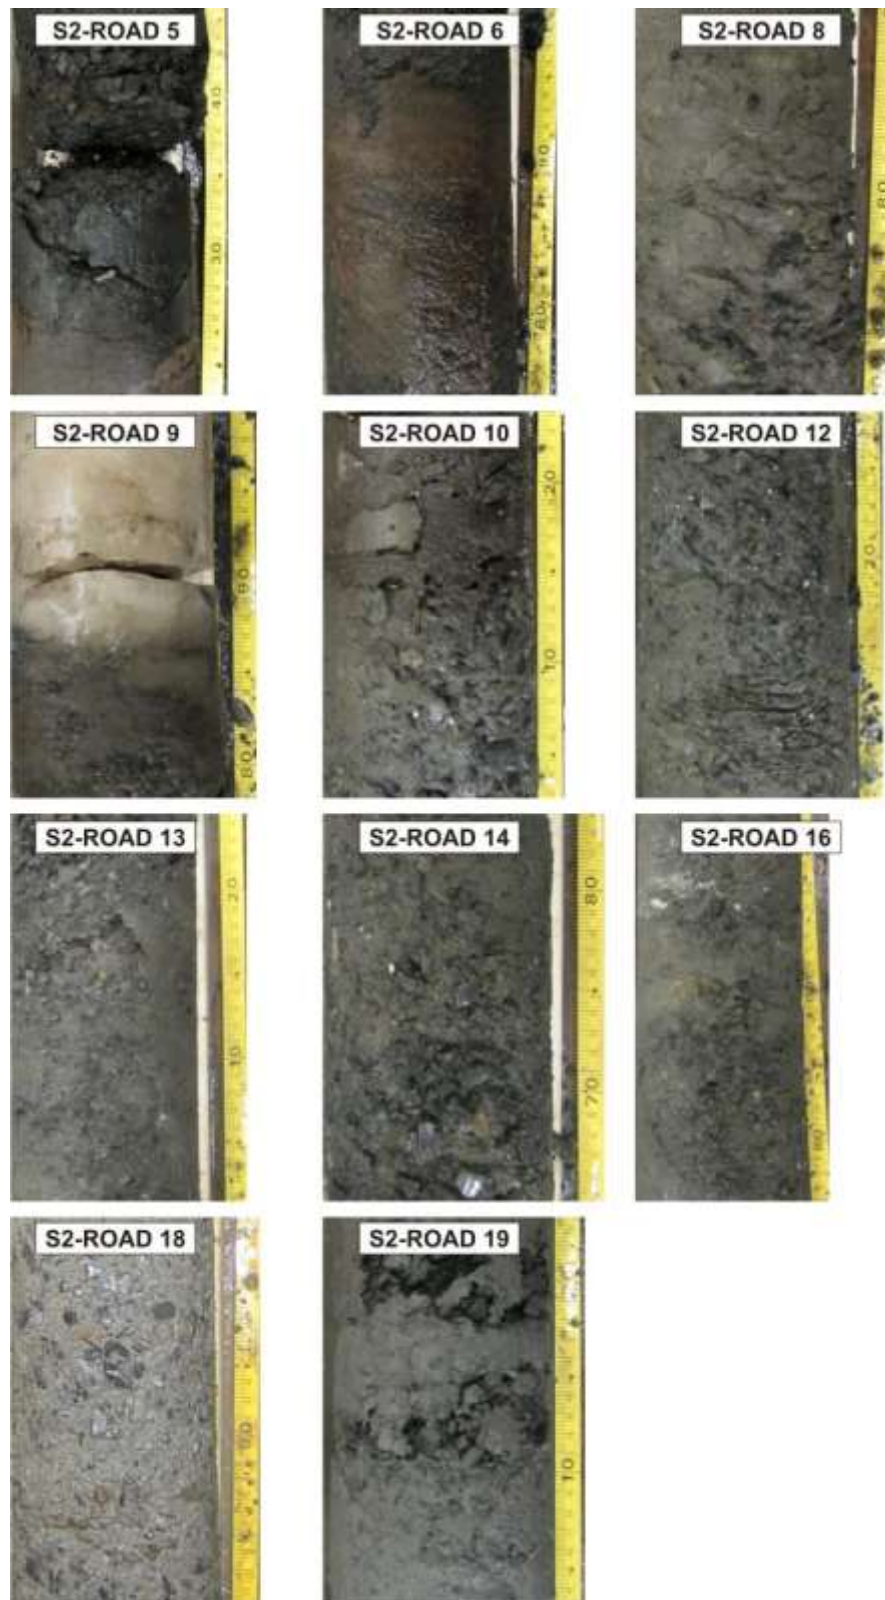
Permafrost features for Site 2 under the road.

S2-Road: located on the road (N66.70093 W136.35862). This site was drilled down to 33 ft (10.0 m). Below the Embankment, 8 ft thick (2.44 m), the soil appeared to be organic grading to silt or clay, ice-rich, with gravelly levels. Nineteen (19) samples were collected. The borehole was stable, and pvc tubing was installed.

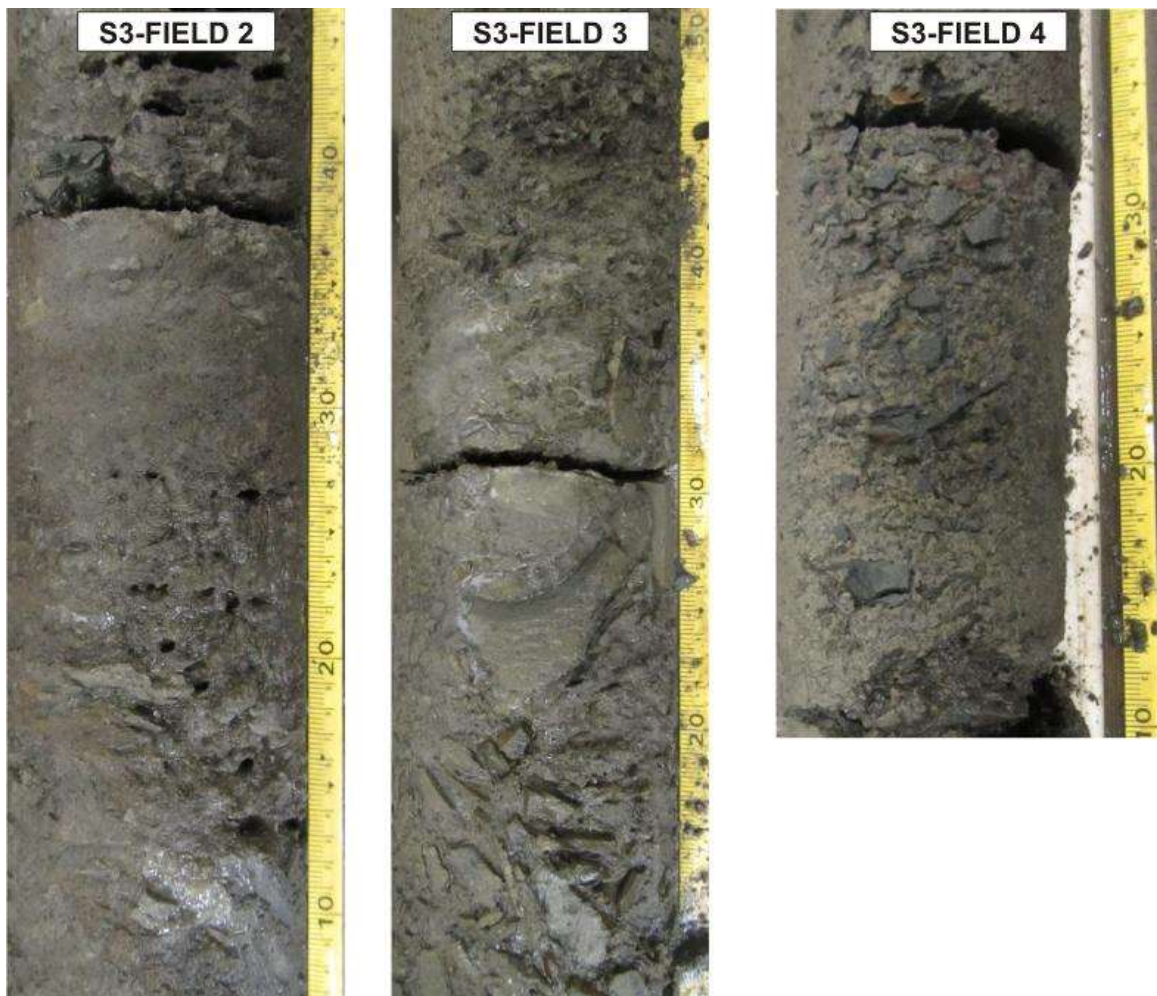
**Permafrost features for Site 3 under the Field.**

S3-Field: located in the field (N67.10929 W136.08854). This site was drilled down to 10.5 ft (3.2 m), reaching bedrock. After fine sediment, coarse material was encountered around 2 m, grading into weathered bedrock, and then bedrock. Five (5) samples were collected. The borehole was stable, and pvc tubing was installed.

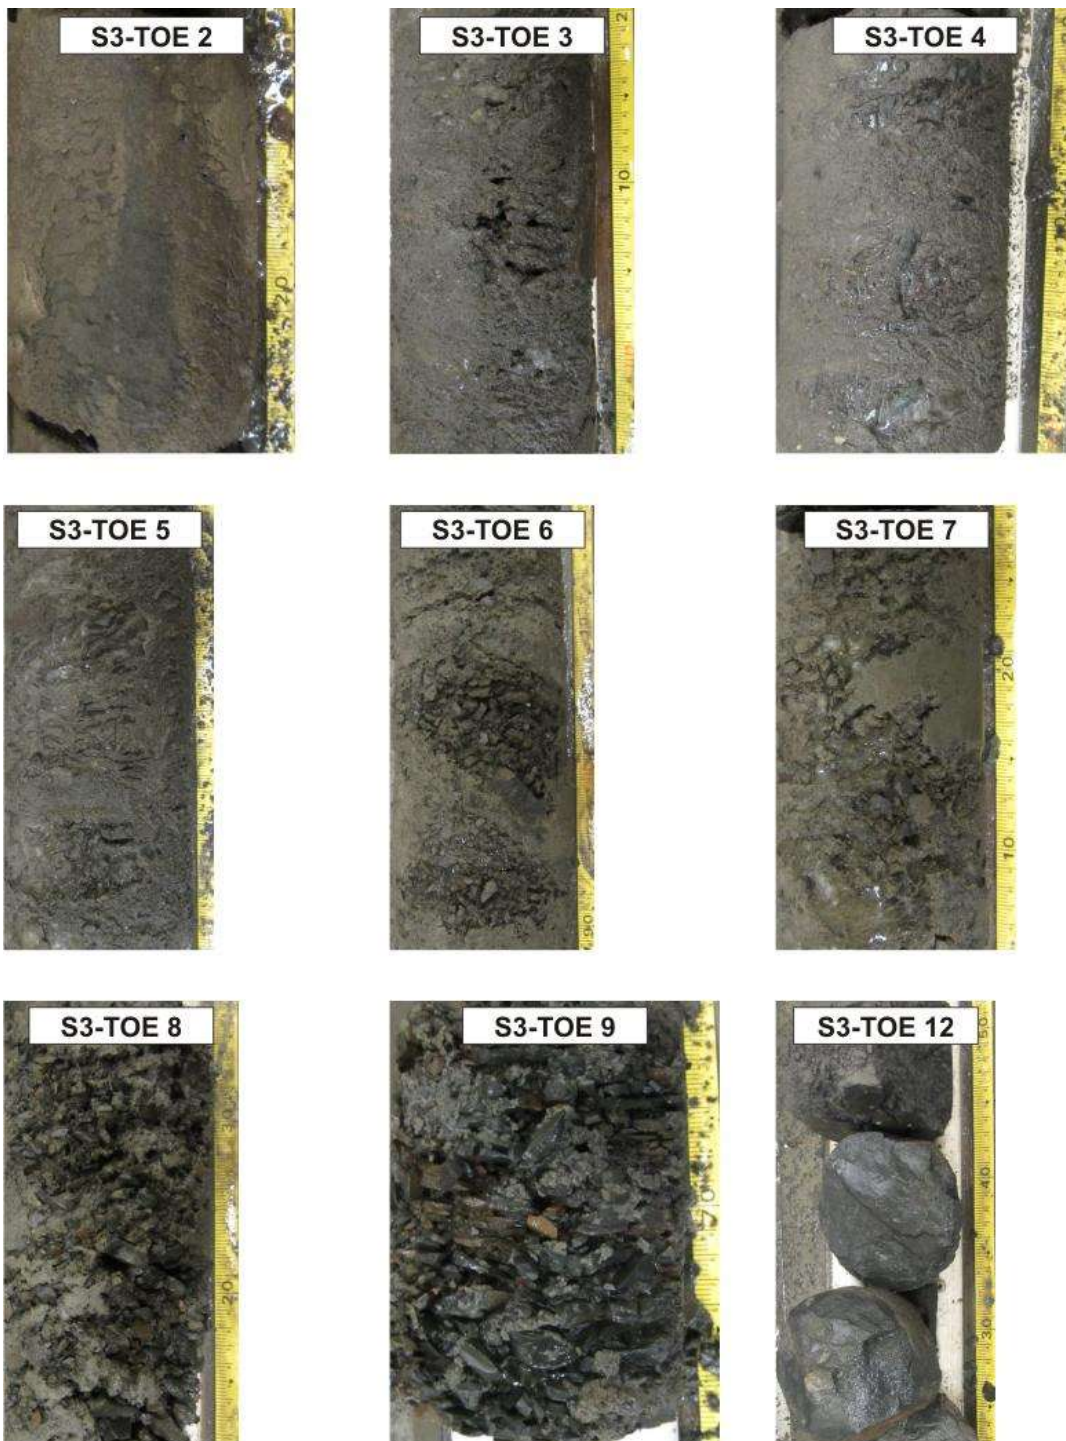
Core No	Soil testing	Soil	Ground Ice
0 m	1		Organic soil (cuttings)	☒ = see facies photo
	2	a, b, c, d, f	Silt - to clean	No visible excess ice
1 m	3		Silt and organics	Layered/lensed ice
	4		Silt and organics	Layered/lensed ice
2 m	5	a, b, d	Silt and organics	Layered/lensed ice
	6		Diamicton with schist debris in silty matrix	Layered to suspended ice
	7		Diamicton with schist debris in silty matrix; cobbles	Layered to suspended ice
3 m	8	a, b, d	Diamicton: Schist debris in silty matrix.	No visible excess ice
	9		Diamicton from weathered bedrock, or slope deposit.	No visible excess ice
4 m	10		Diamicton from weathered bedrock, or slope deposit.	No visible excess ice
	11		Diamicton from weathered bedrock, or slope deposit.	No visible excess ice
5 m	12		Bedrock, altered.	No visible excess ice
6 m	13	a, d 5.94 m 6.10 m	Bedrock, altered.	No visible excess ice
7 m				
8 m				
9 m				
10 m

**Permafrost features for Site 3 under the toe of the Embankment.**

S3-Toe: located at the toe of the embankment (N67.10924 W136.08825). This site was drilled down to 20ft (6.1 m), reaching bedrock. The soil appeared to be fine sediment from ground surface to 2.4 m approximately, and then soil evolves into schist debris, probably weathered bedrock. Thirteen (13) samples were collected. The borehole was stable, and pvc tubing was installed.

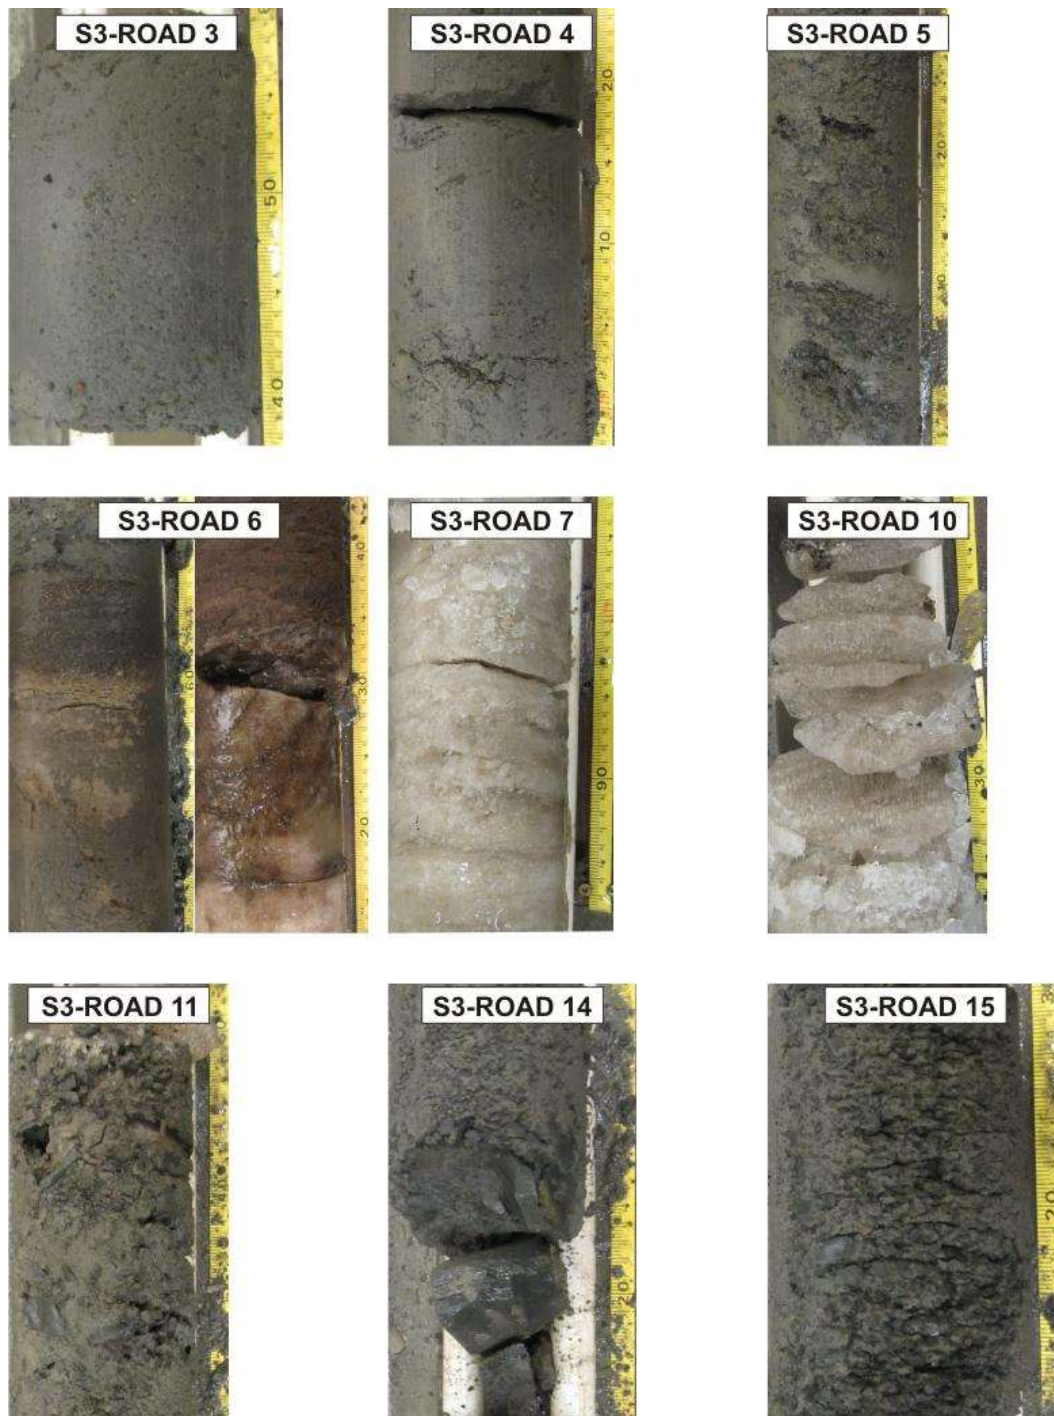
Permafrost features for Site 3 under the road.

S3-Road: located on the road (N67.10919 W136.08800). This site was drilled down to 27.5 ft (8.4 m), reaching bedrock. Below the Embankment, tentatively 8 ft thick (4.0 m), fine organic soil occurs with the presence of wedge ice. Deeper, at about 6.8 m, the soil appeared to be weathered schist grading into bedrock with depth. Fifteen (15) samples were collected. Fifteen (15) samples were collected. The borehole was stable, and pvc tubing was installed.

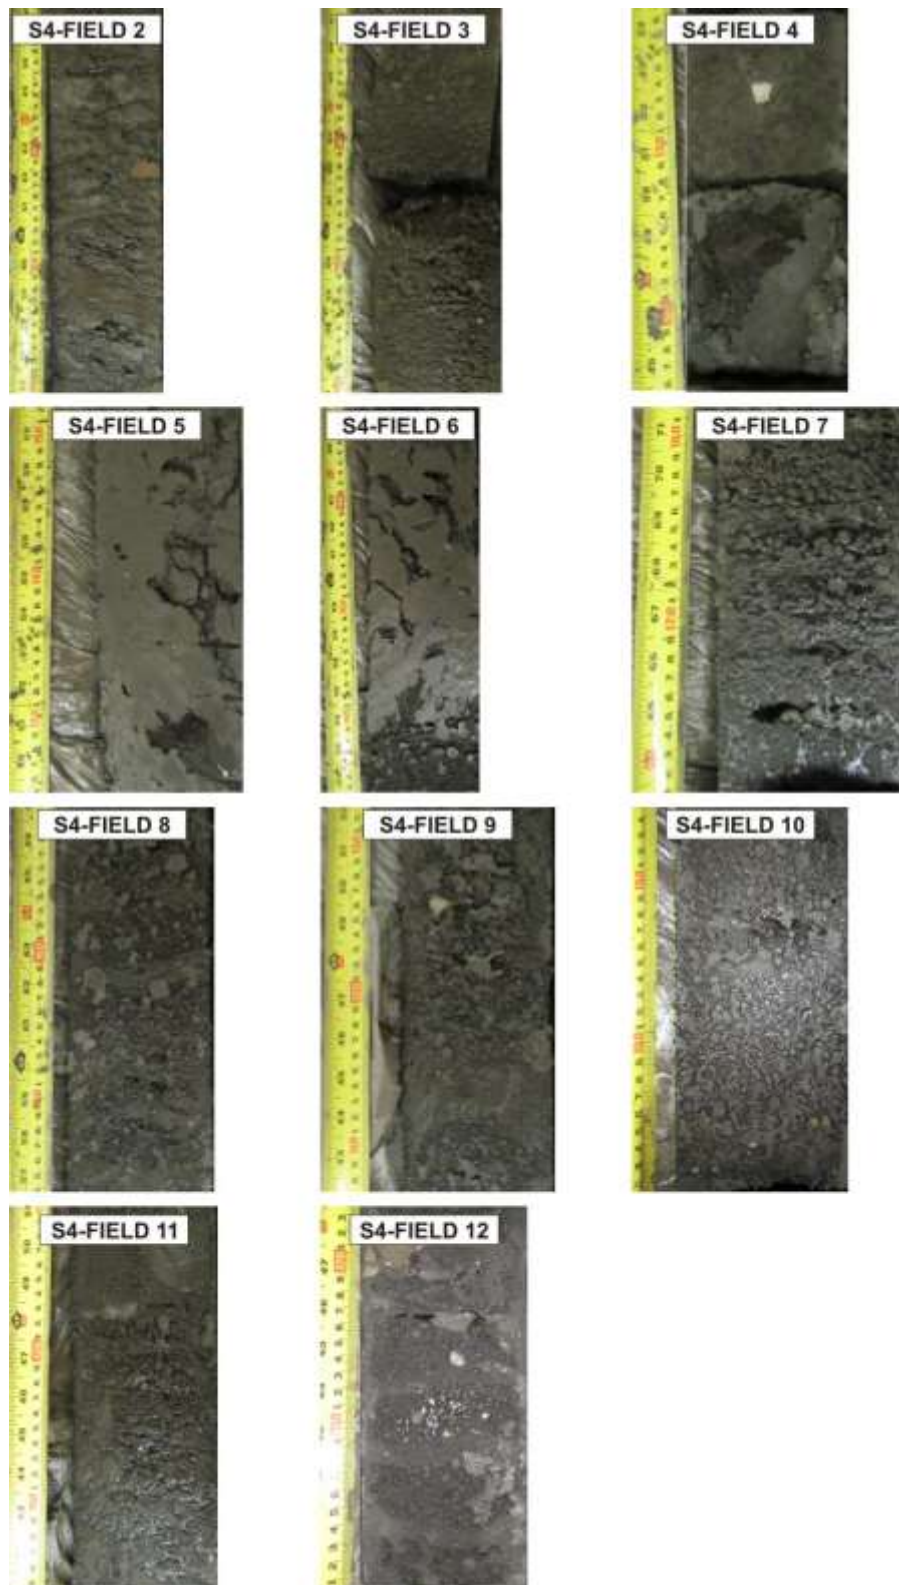
**Permafrost features for Site 4 under the Field.**

S4-Field: located in the field (N67.24115 W135.26290). This site was drilled down to 27.5 ft (8.4 m). The soil consisted in ice-rich silt with erratic bed of gravel. The cores were frozen (12 cores in total), but yet discrepancy exist between core length and depth. The borehole was stable, and pvc tubing was installed.

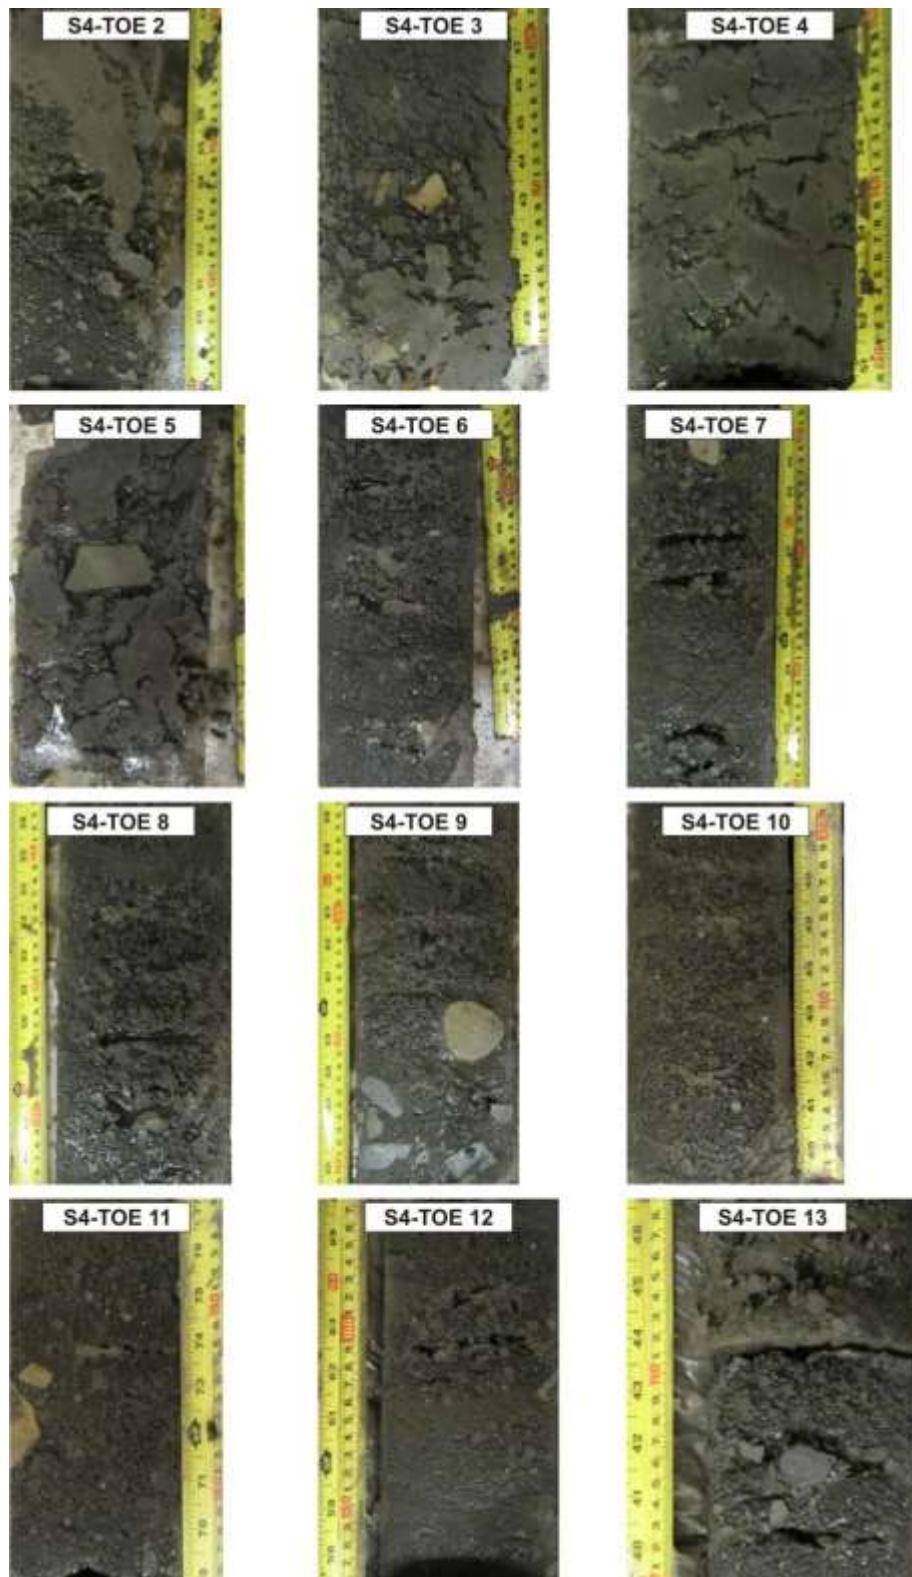
**Permafrost features for Site 4 under the toe of the Embankment.**

S4-Toe: located at the toe of the embankment (N67.24103 W135.26304). This site was drilled down to 27 ft (8.23 m). The soil consisted in ice-rich silt with erratic bed of gravel. The cores were frozen (13 cores in total), but Discrepancy exist between core length and depth due to decompression induced by the drilling process. The borehole was stable, and pvc tubing was installed.

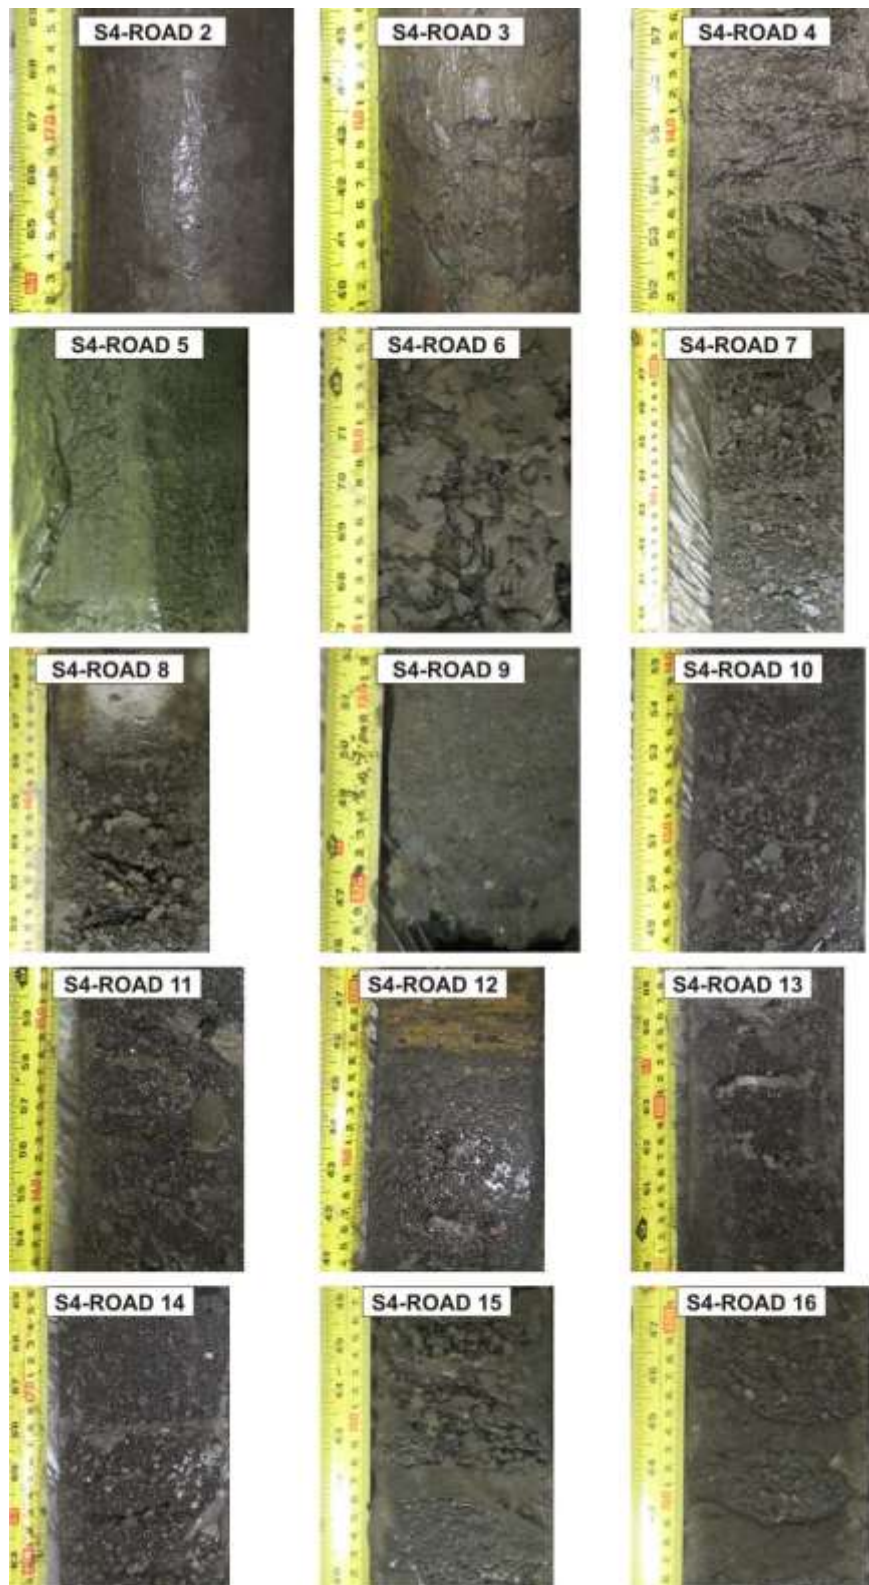
Permafrost features for Site 4 under the road.

S4-Road: located in the road embankment (N67.24092 W135.26307). This site was drilled down to 33 ft (10.06 m). After 2 m of embankment, the soil still consisted in ice-rich silt with erratic bed of gravel. The cores were frozen (16 cores in total), but yet discrepancy exist between core length and depth. The borehole was stable, and pvc tubing was installed.
